RESIDENTIAL PROPERTY CONDITION ASSESSMENT REPORT

**Residential Single Family Home
Self-Structure Building**

**745 NW 5th Court
Hallandale Beach, FL 33009**

In Regards To	745 NW 5 th Court, Hallandale Beach, FL 33009		
Prepared For	City of Hallandale Beach	Dates of Inspection	July 03, 2013
Requested By	Community Redevelopment Agency	Year Built	1969
Soil & Weather	Dry Soil & Sunny -97°F	Property ID	5142-21-19-0620

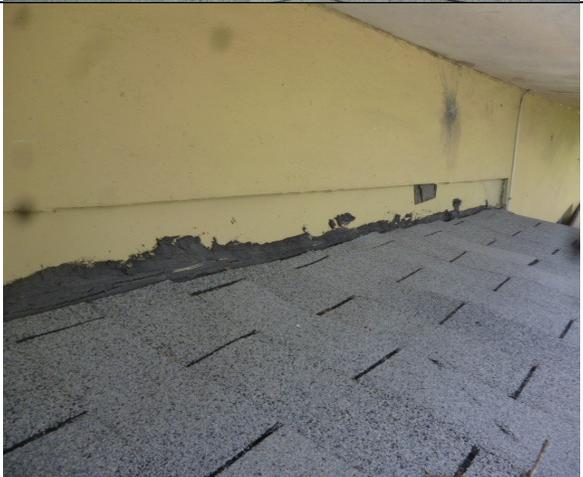
<p>(6)</p> <p><i>The subject property roof shingles/wall joints need to be sealed properly</i></p>

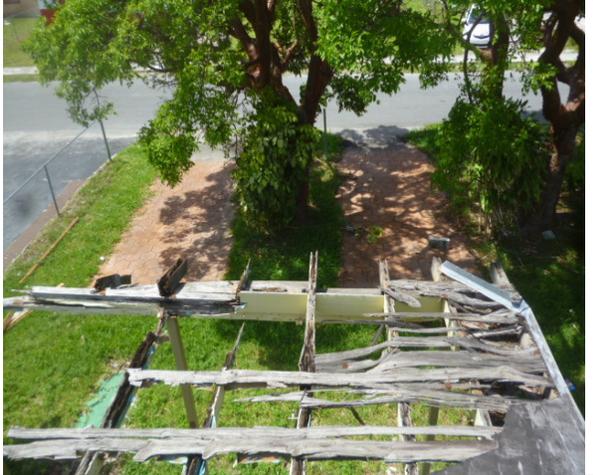
<p>(7)</p> <p><i>The subject property south elevation patio roof is severely damaged</i></p>

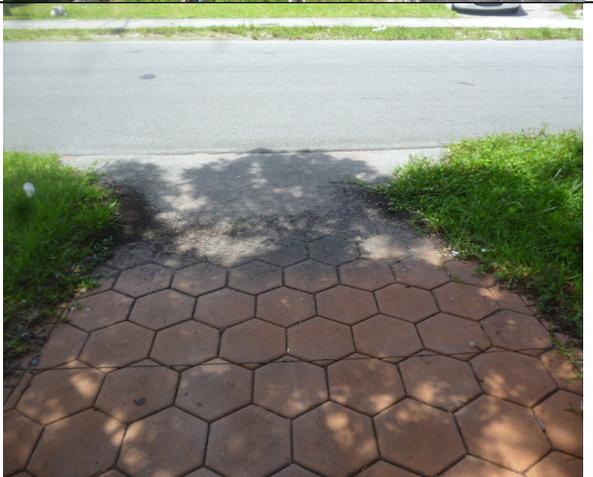
<p>(8)</p> <p><i>The subject property south elevation patio floor drainage needs to be maintained</i></p>

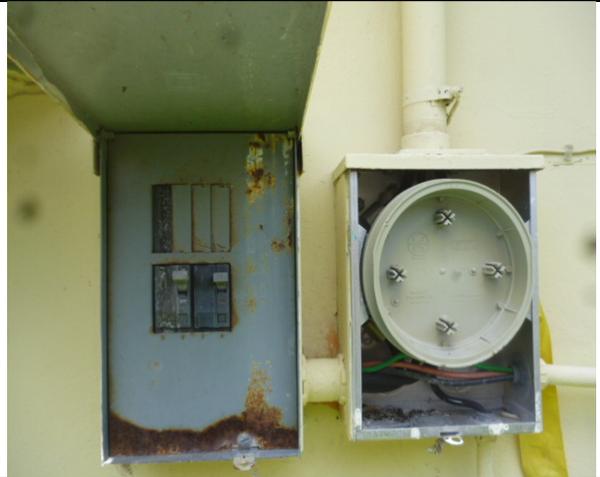
Severely deteriorated/damaged/rusty exterior electrical circuit main breaker panel needs to be replaced

Missing electrical meter noted

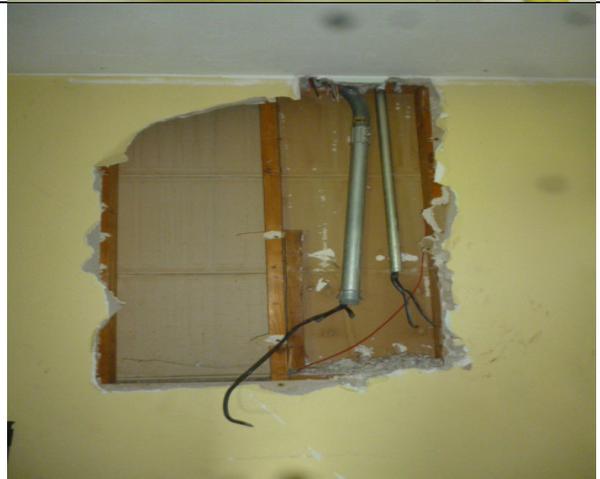
(10)

Interior main electrical circuit breakers panel is missing

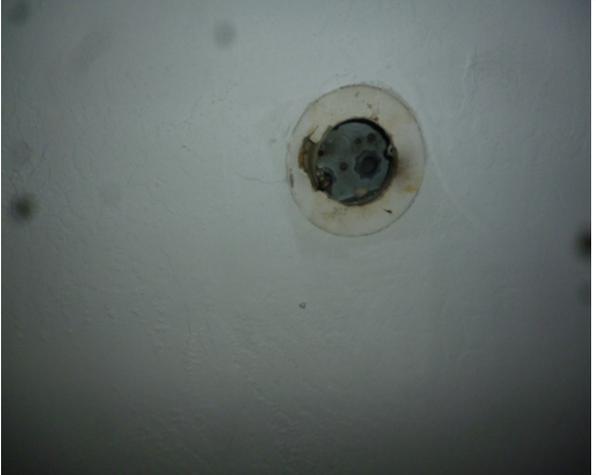
<p>(11)</p> <p><i>Missing light fixtures/wiring</i></p>

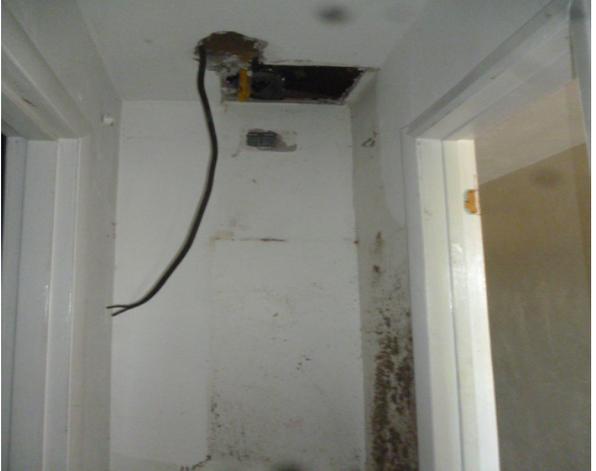
<p>(12)</p> <p><i>Missing central HVAC system unit</i></p>

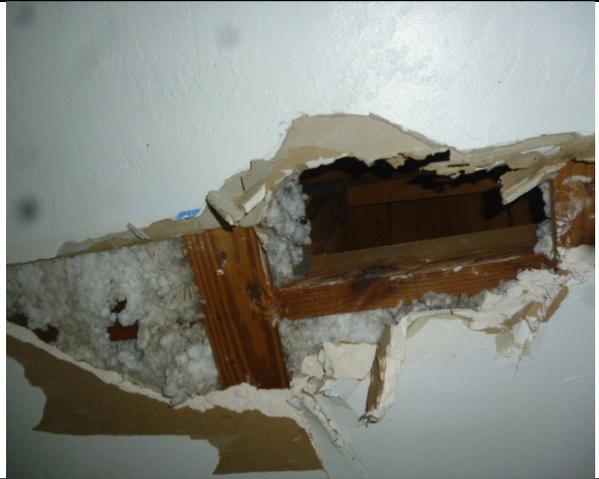
(13)

Damaged interior ceiling materials

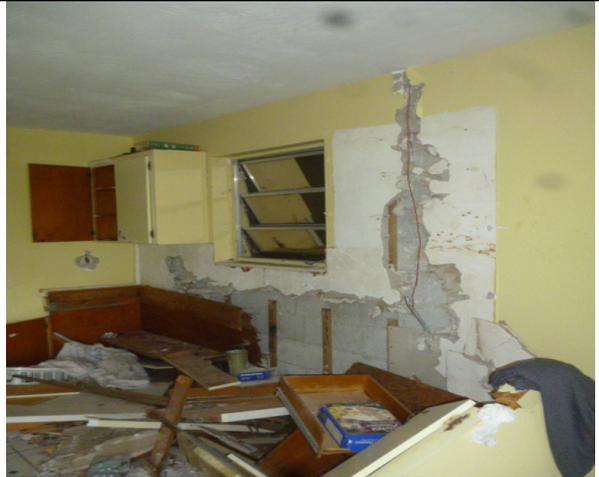
(14)

Severely damaged kitchen drywalls and cabinets need to be replaced

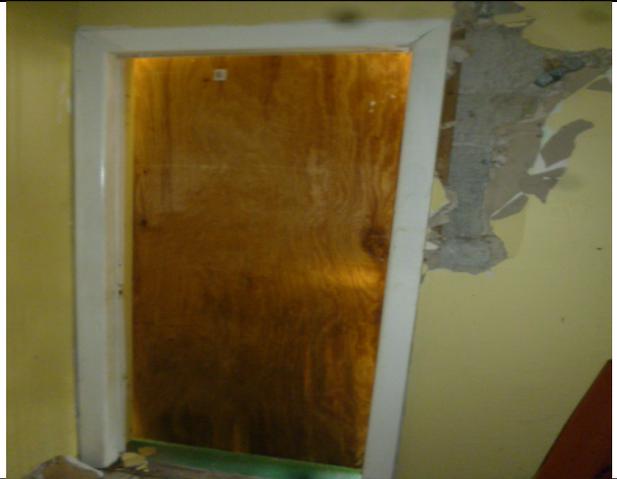
(15)

Missing west elevation exterior door must be installed

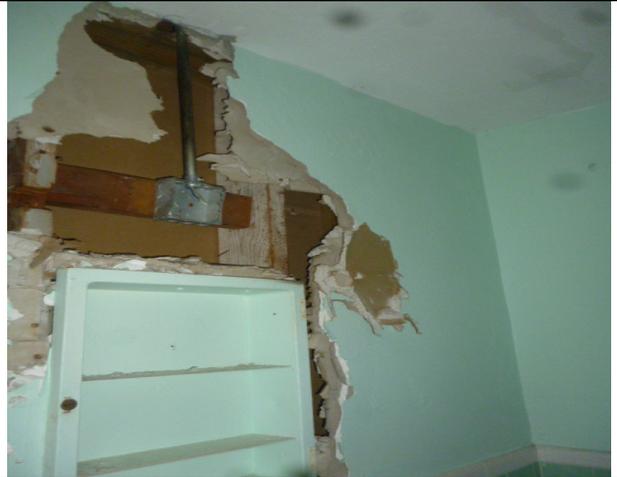
(16)

Severely damaged bathroom walls

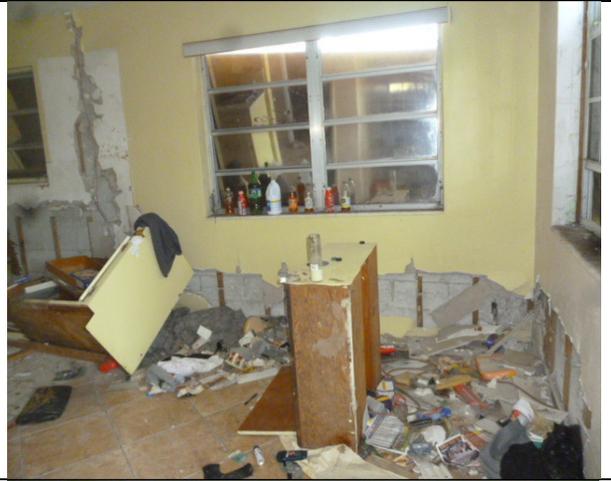
(17)

Severely damaged interior drywalls

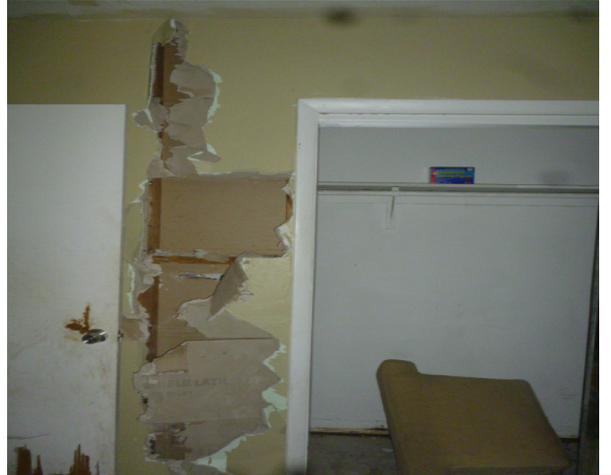
(18)

Severely damaged interior drywalls in the bedrooms

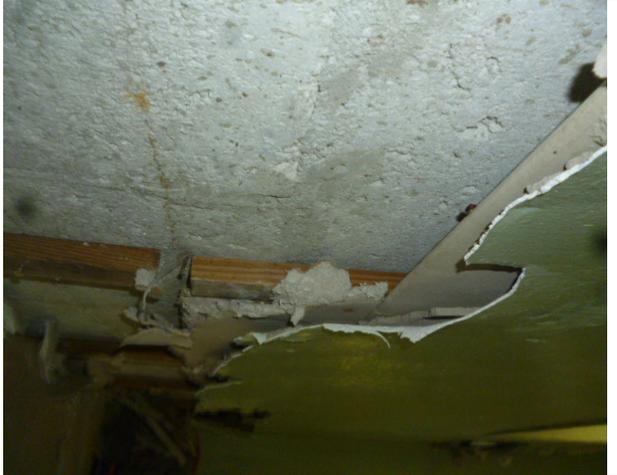
<p>(19)</p> <p><i>Missing drywalls and damaged wooden frames</i></p>

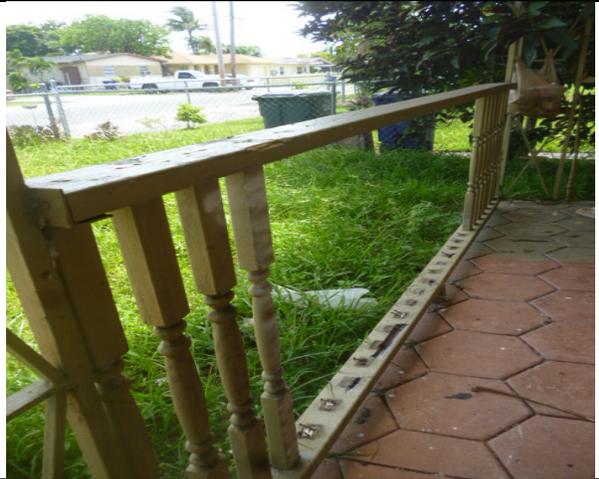
(21)

Damaged hand railings at front elevation

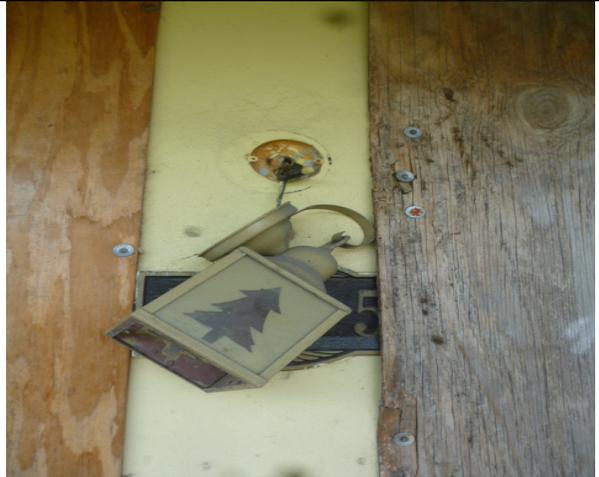
(22)

Severely damaged exterior light fixtures

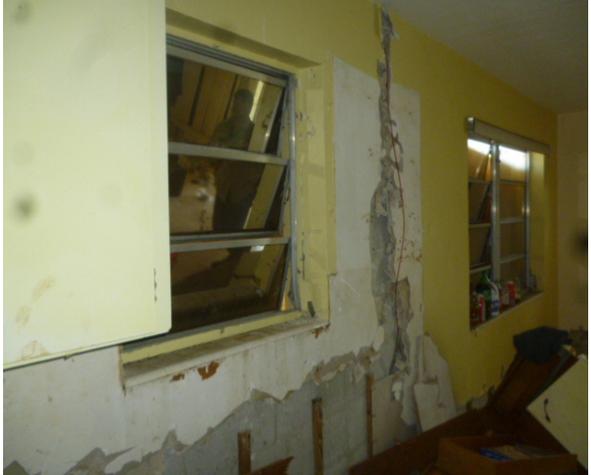
<p>(23)</p> <p><i>Severely damaged interior drywalls and the window frames</i></p>

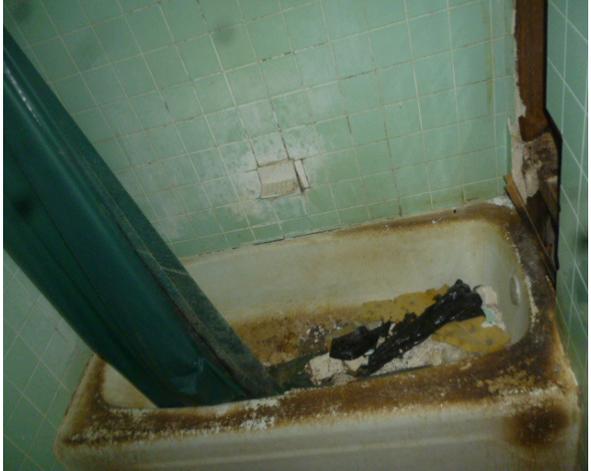
<p>(24)</p> <p><i>Severely damaged bathroom walls and the fixtures</i></p>

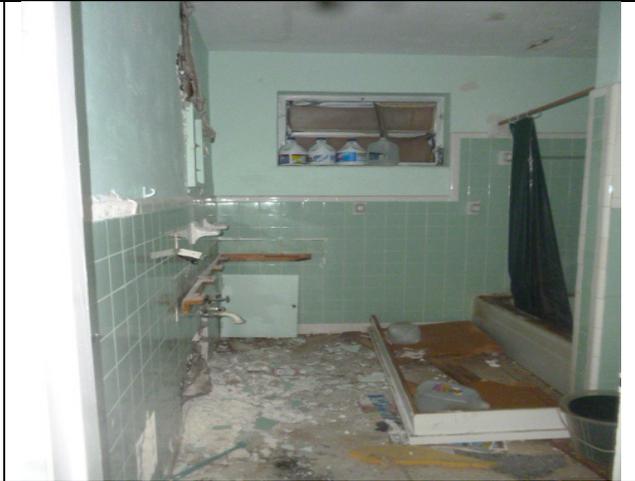
(25)

Missing/damaged bathroom cabinets and the plumbing fixtures

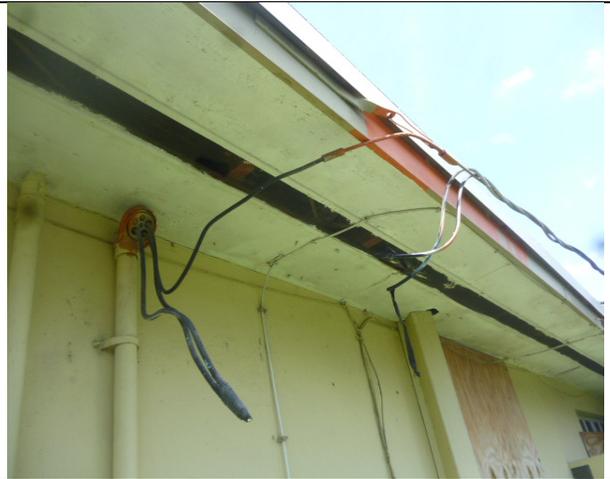
(26)

Missing/cut main electrical service mast cables

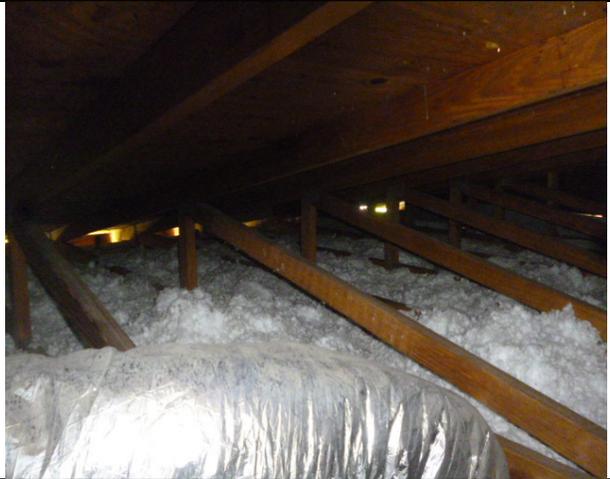
(27)

Central HVAC system air duct work needs to be properly maintained/repaired

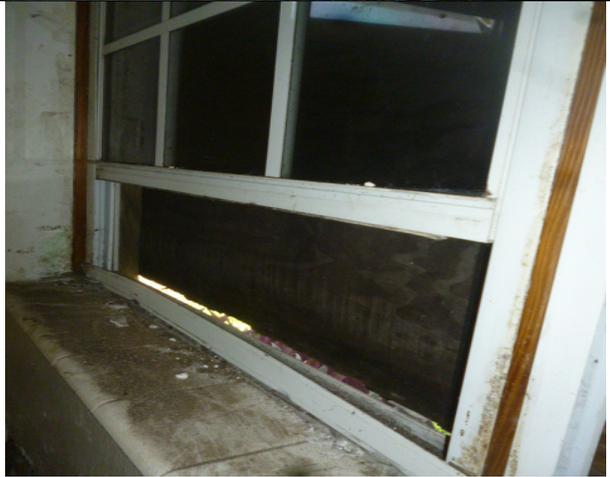
(28)

Missing/damaged window frames and glasses

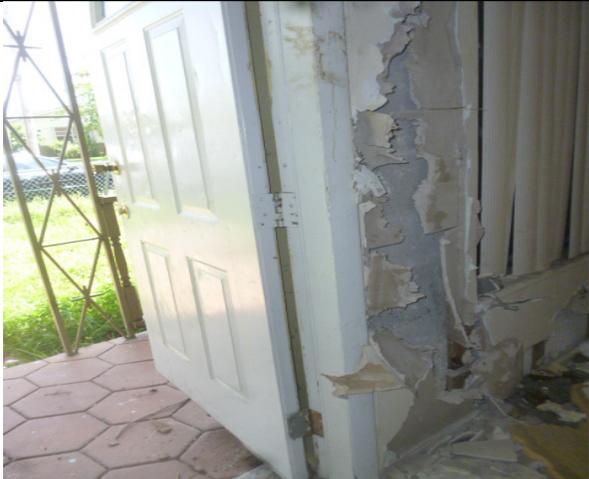
<p>(29)</p> <p><i>Damaged drywalls by the main entrance door</i></p>

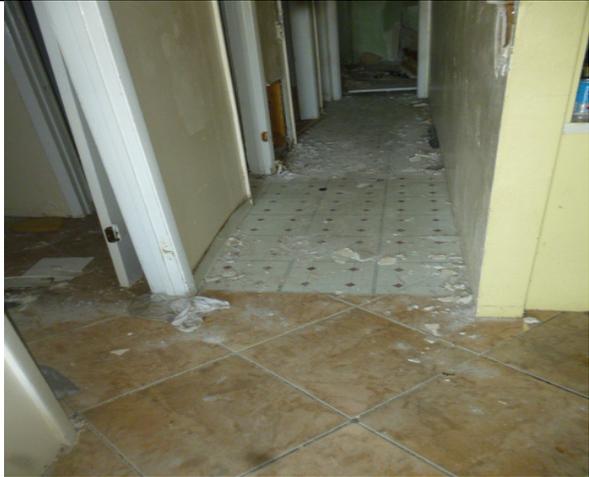
<p>(30)</p> <p><i>Flooring material is partially damaged</i></p>

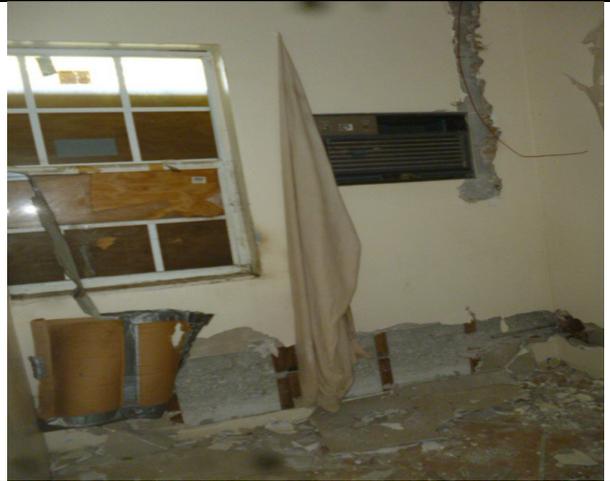
(31)

Severely damaged drywalls and the flooring materials in the bedrooms

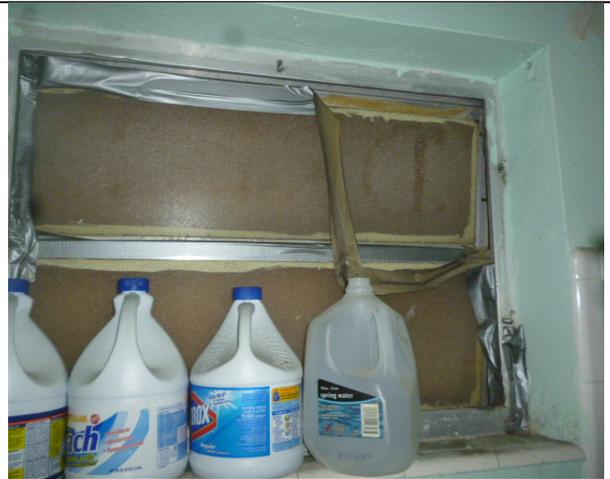
(32)

Severely damaged window frames need to be replaced

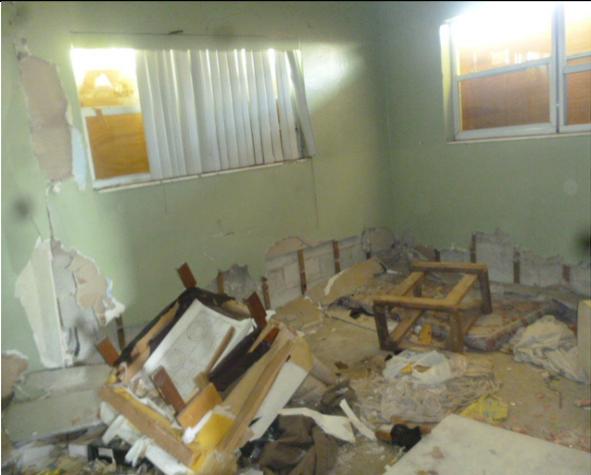
<p>(33)</p> <p><i>Damaged bedroom drywalls and flooring materials</i></p>

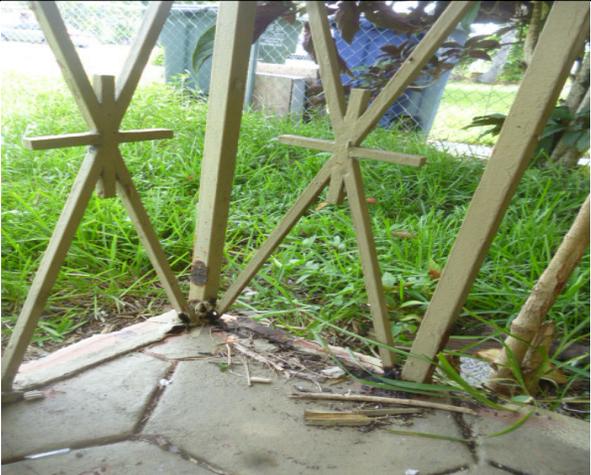
<p>(34)</p> <p><i>Damaged main entry exterior hand railing materials need to be replaced</i></p>
