RE: EPAC Project #: 2066797
Storage Tank Closure Assessment Report for
Garic Autobody Property
513 N. Dixie Highway
Hallandale Beach, FL 33009

STORAGE TANK CLOSURE ASSESSMENT REPORT
FOR THE
GARIC AUTOBODY PROPERTY
513 N. DIXIE HIGHWAY
HALLANDALE BEACH, FL 33009

JUNE 23, 2006
EPAC PROJECT #: 2066797

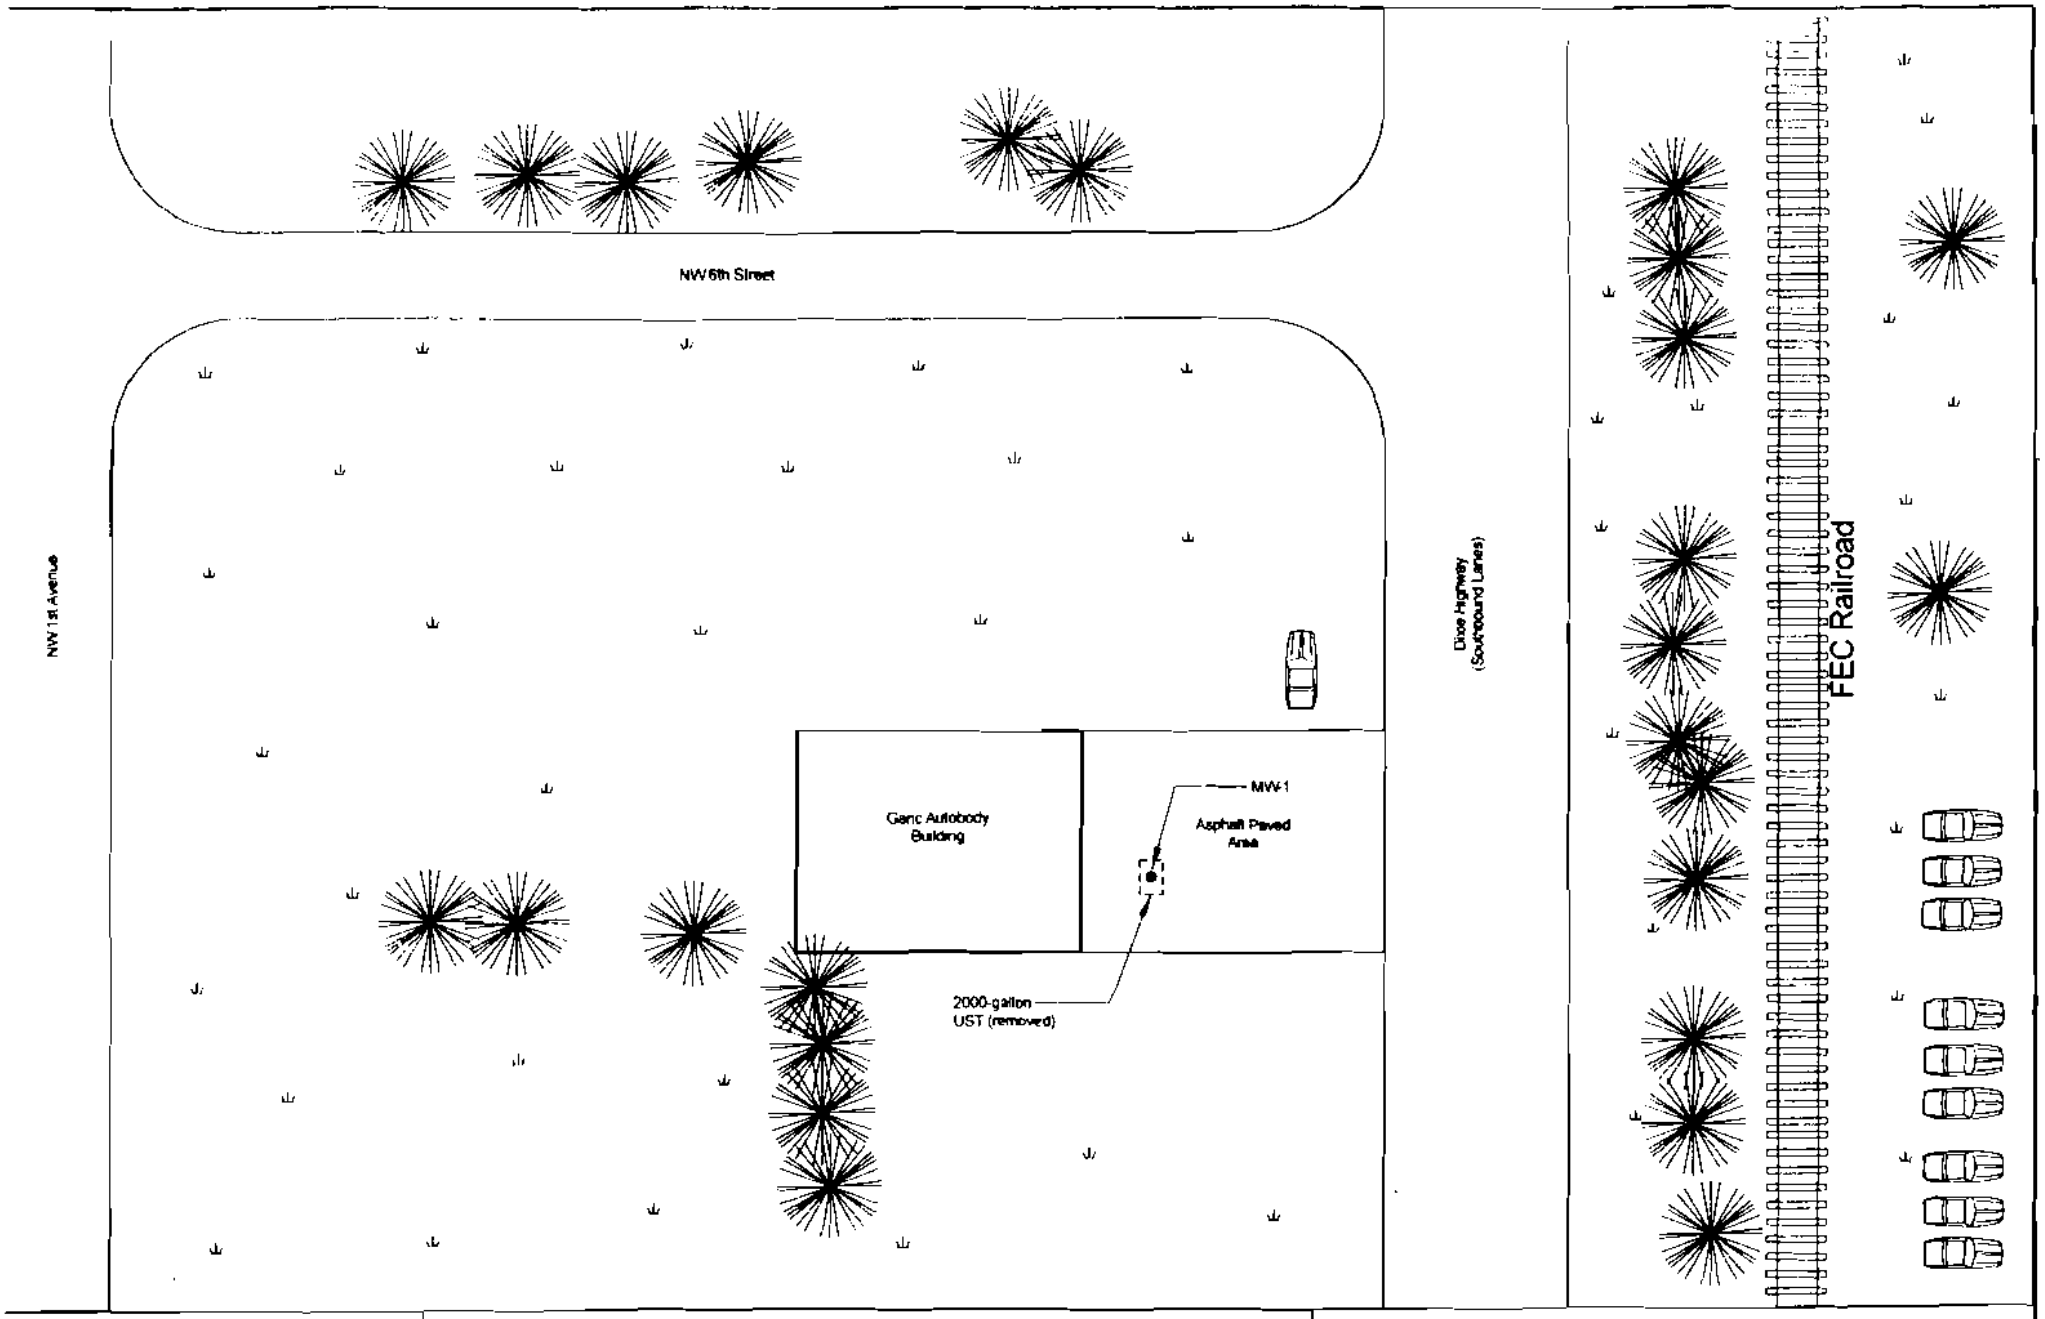
FIGURE 2
SITE PLAN MAP

The tank inventory consisted of one (1) single-walled steel underground storage tanks (UST) which measured approximately 2,000 gallons (See Site Plan, **Figure 2**). The tank, which was full of liquid, appeared to be in good condition with no evidence of holes or corrosion upon removal.

One (1) groundwater monitoring well was installed on May 18, 2006, by CM2 Drilling, Inc., a state licensed drilling contractor. The groundwater well, labeled MW-1, was installed to a depth of fifteen (15) feet below the surface. The first occurrence of groundwater was encountered at approximately six and a half (6.5) feet below the surface. The well casing, comprised of two (2) inch diameter schedule 40 PVC piping, contained ten (10) feet of 0.010 slot screening. After installation of the sand pack, the well was developed in order to properly clean the sand pack. A Site Plan indicating the monitoring well location is included in **Figure 2**.

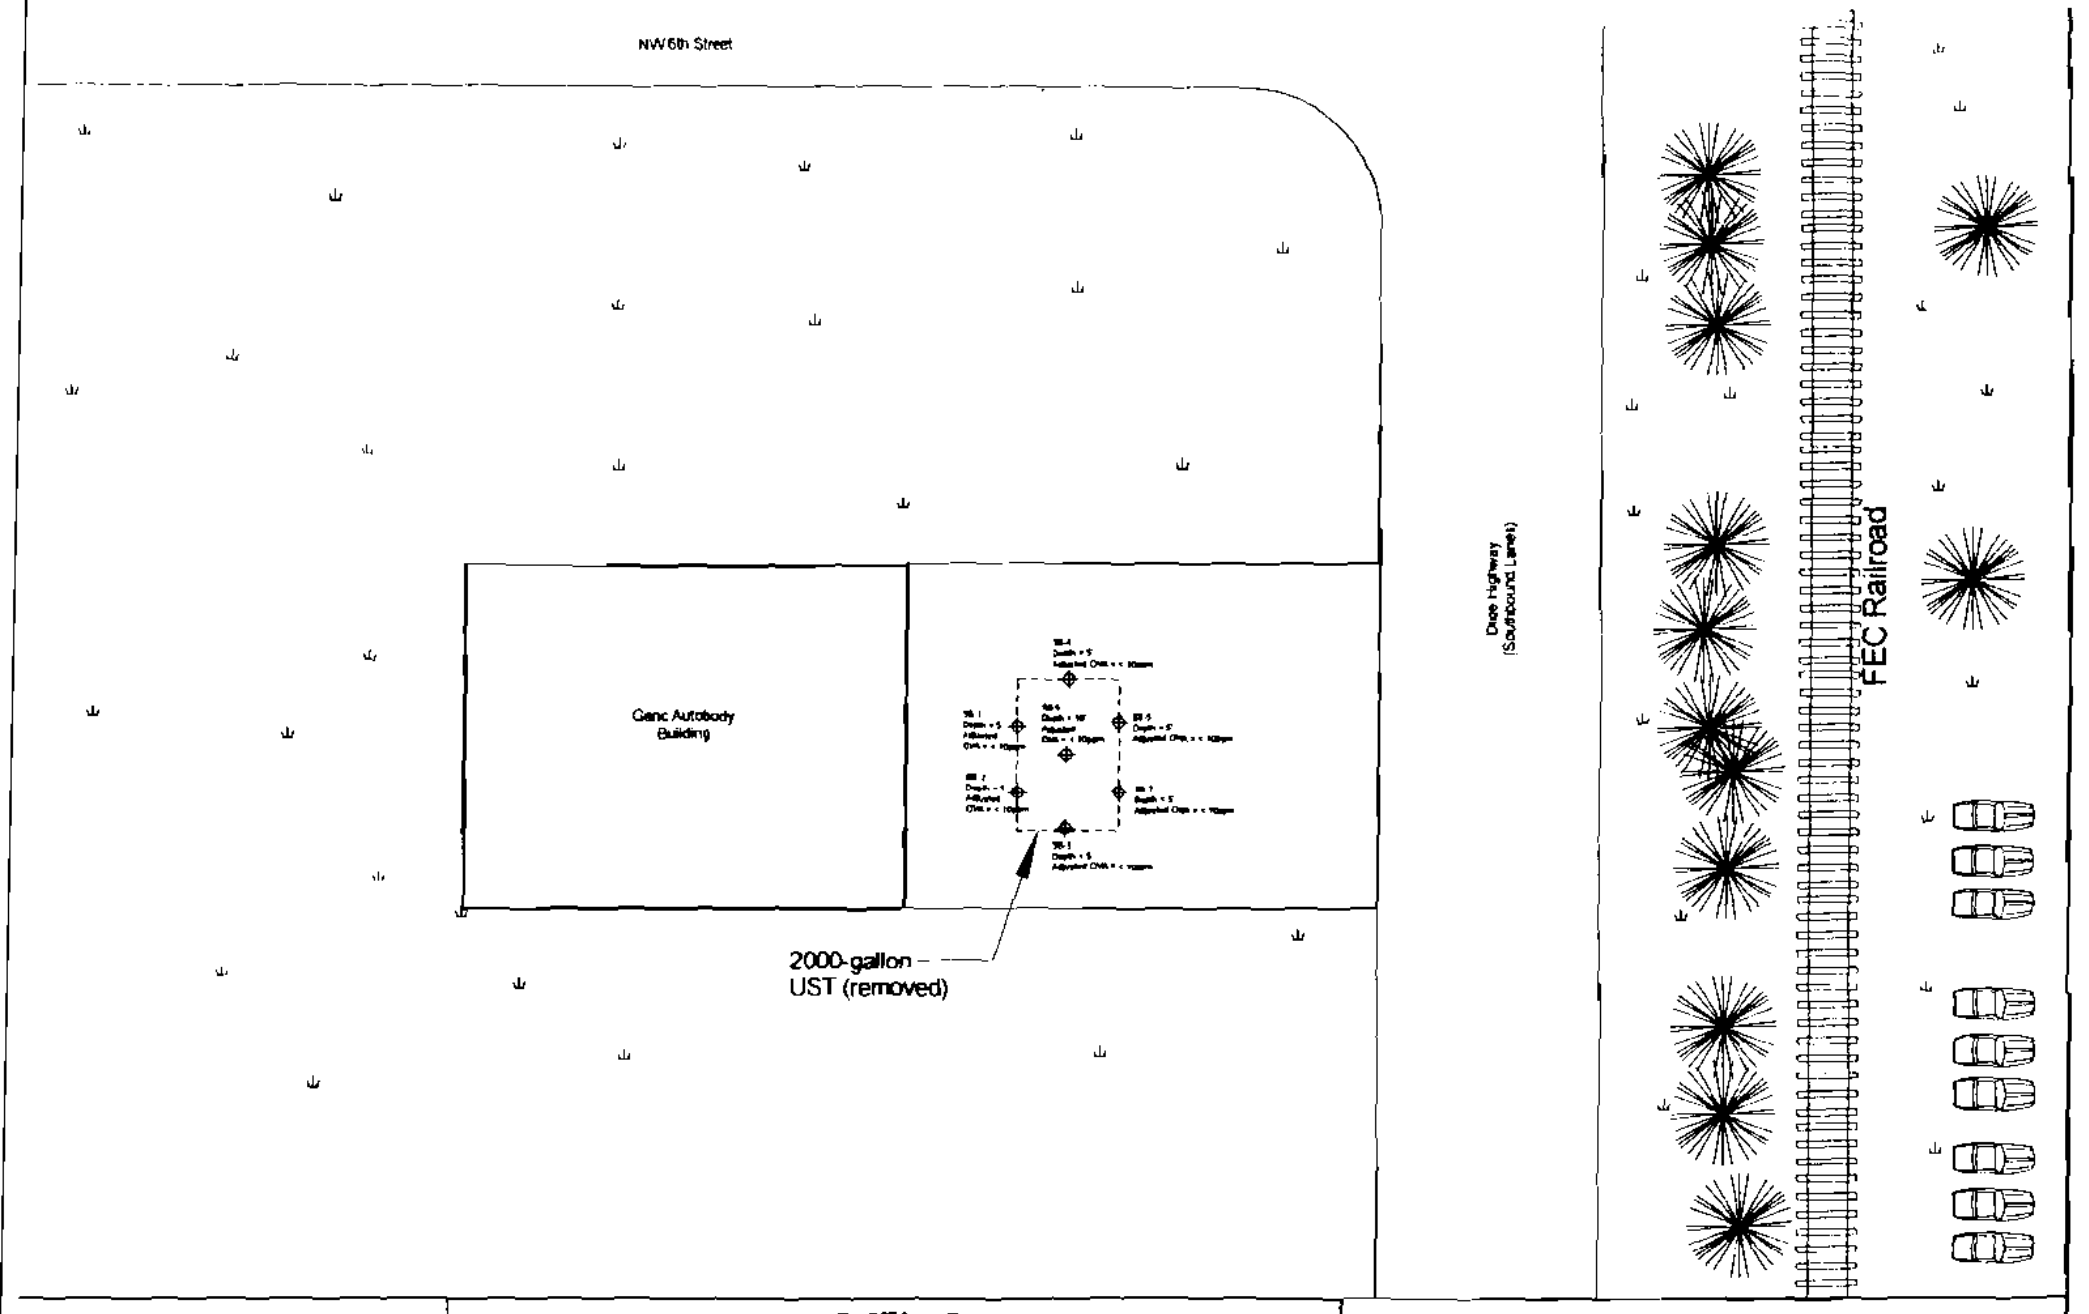
FIGURE 3
SOIL SAMPLE LOCATION MAP

The soil screening for all seven (7) soil grab samples reported adjusted organic vapor analyzer (OVA) readings below ten (10) parts per million (ppm). **Table 1** provides a summary of the soil screening results. A site plan map detailing the soil sampling locations is provided as **Figure 3**.
